# Vandalproof IK10 MVT - AH26W

## ● SPECS

# 1. TEST SUMMARY

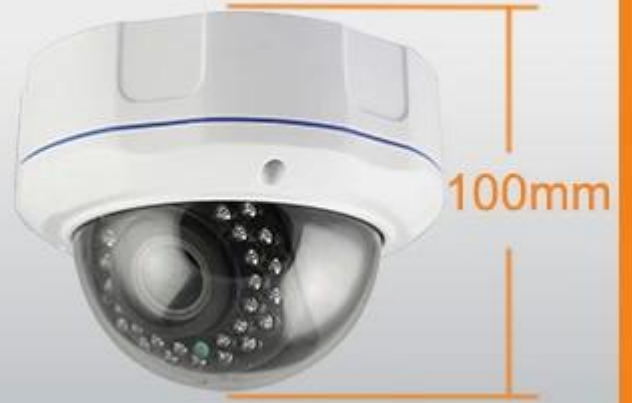
Metal Housing

30 pcs Leds  
IR Distance 30m
